WRIGHT GROUP INC.

Scott Blake

250 Edwards Boulevard
Lake Geneva, WI

INTRODUCTION:

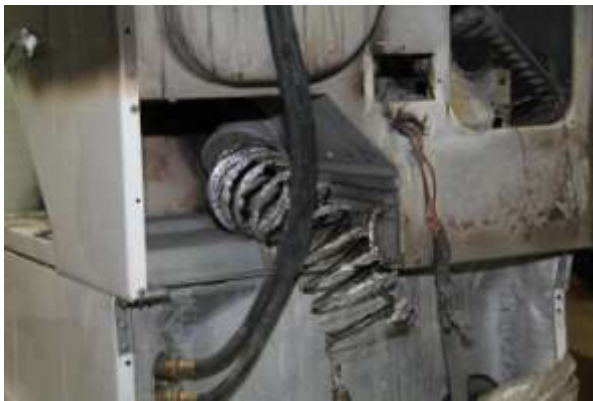
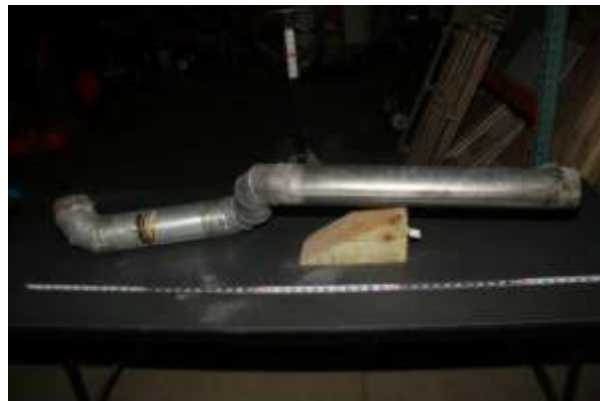
Venting Components

A portion of the venting had been included with the evidence. It consisted of a combination of flexible foil and rigid permanent ducting. Eighteen coils of flexible foil ducting were connected to the dryer. The flexible foil ducting was still clamped to the dryer at the time of this inspection. There were not any remains of lint in the flexible foil or the internal dryer duct. The permanent ducting consisted of approximately 4 feet of rigid metal duct, comprised of two straight sections and three 90 degree rigid metal elbows. When reconstructed in its original positioning, it totaled approximate 4 ½ feet in length. A very slight amount of lint was observed in the permanent ducting. The elbow that would have been positioned within the laundry closet closest to the vent connection at the rear of the appliance was equipped with a couple coils of wire from the flexible duct, connected via a band clamp. Charred lint was seen at the 90 degree elbow that was attached to the flexible foil duct. The venting was not arranged in the same form that the employees of Blake Capital recalled in their depositions, with rigid venting extending further down into the laundry closet than ceiling level. This indicated the permanent duct connection was at approximately the same height as the vent connection on the rear of the appliance. This allowed that the flexible foil was in its shortest length possible. The remainder of the permanently installed duct system in the attic was not collected or documented in any information provided to the Wright Group to date.

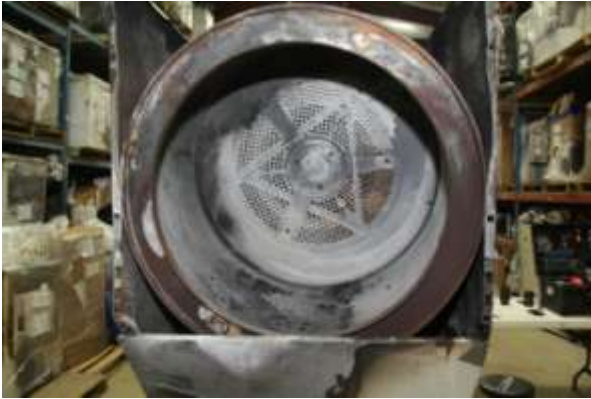
Drum Opening

Examination of the drum opening and door of the dryer revealed both were directly fire damaged, with the concentration of fire patterns emanating from the area of the trap duct and blower housing at the left front corner. The interior of the door displayed heavy oxidation and the door gasket and label on the interior of the door had been entirely consumed. The door latch and door switch had both been heavily fire damaged, and the door latch was no longer securing the door. The lint trap and filter had been consumed. The dryer load, found previously secured in a plastic bag, was heavily fire damaged. The drum was rotated post fire and the visible load line had shifted.

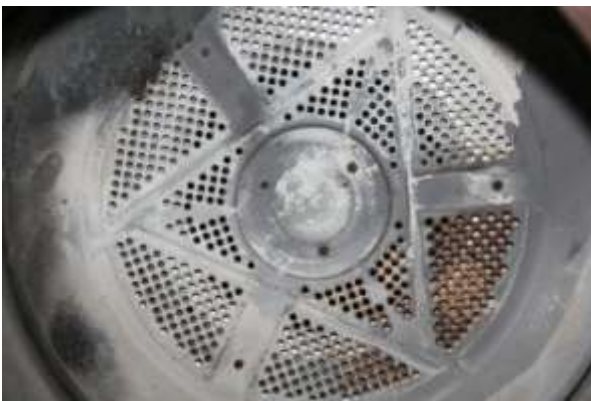
Interior of the Drum

The interior of the drum also displayed heavy fire damage and the drum paddles had been entirely consumed. Fire patterns observed in the drum were not consistent with the fire originating in the load, but rather that the drum was attacked by fire from the plastic blower assembly and trap duct below and to the left.

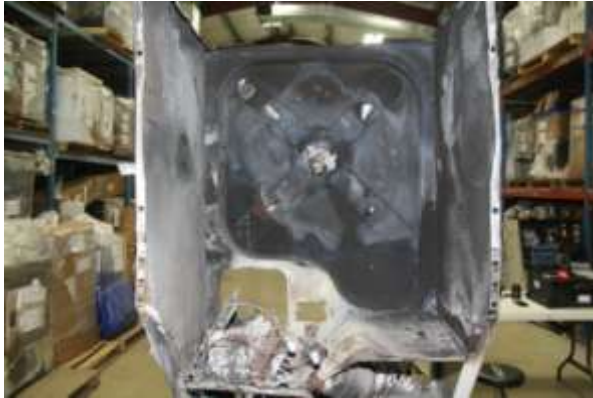
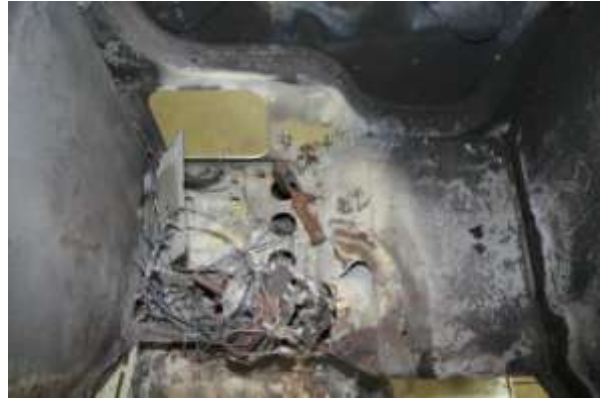
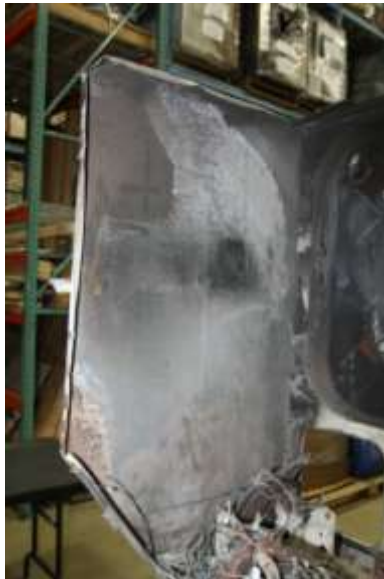
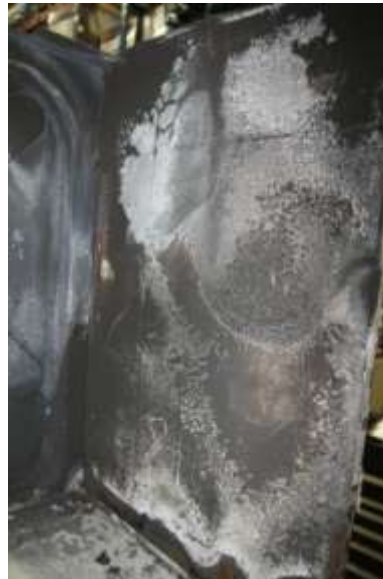
Interior of Dryer Cabinet

The interior of the dryer cabinet had sustained localized fire damage at and surrounding the blower housing at the left side, and fire damage to the rear wall and heater housing. The wiring harnesses and power cord connections observed inside of the dryer cabinet were consumed.

Electrical activity was observed on stranded conductors that had dropped to the dryer base at the motor location.

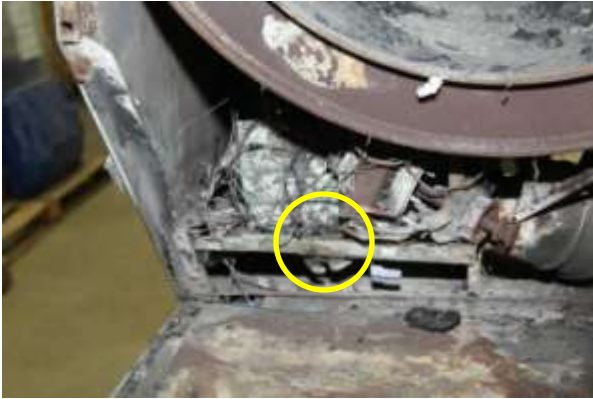
Operational Thermostat at Blower Housing

The plastic fan and blower housing had been completely consumed during the fire. The operational thermostat attached to the blower housing was destroyed during the fire and was not testable. Examination of the automatic re-settable and one-shot high limit safety switches revealed both were damaged by the fire. The one shot high limit safety switch had been removed post-fire. The automatic resettable high limit safety device was in place at the 11 o'clock position of the heater housing. The automatic resettable high limit safety device was not testable due to its post-fire condition. A visual inspection of its contacts was conducted. There was nothing to indicate the contacts had welded together, thus defeating the protection provided by this safety device. The contacts did display evidence of repeated cycling. Based upon the physical evidence it was determined that the automatic resettable high limit safety switch had operated repeatedly over the lifetime of dryer use due to elevated temperatures behind the drum from a reduction of airflow within the dryer. A cause of this would be related to reduced airflow within the dryer. Causes of reduced airflow include exhaust restrictions, inadequate make-up air, large loads and defective internal seals, and any combination thereof.

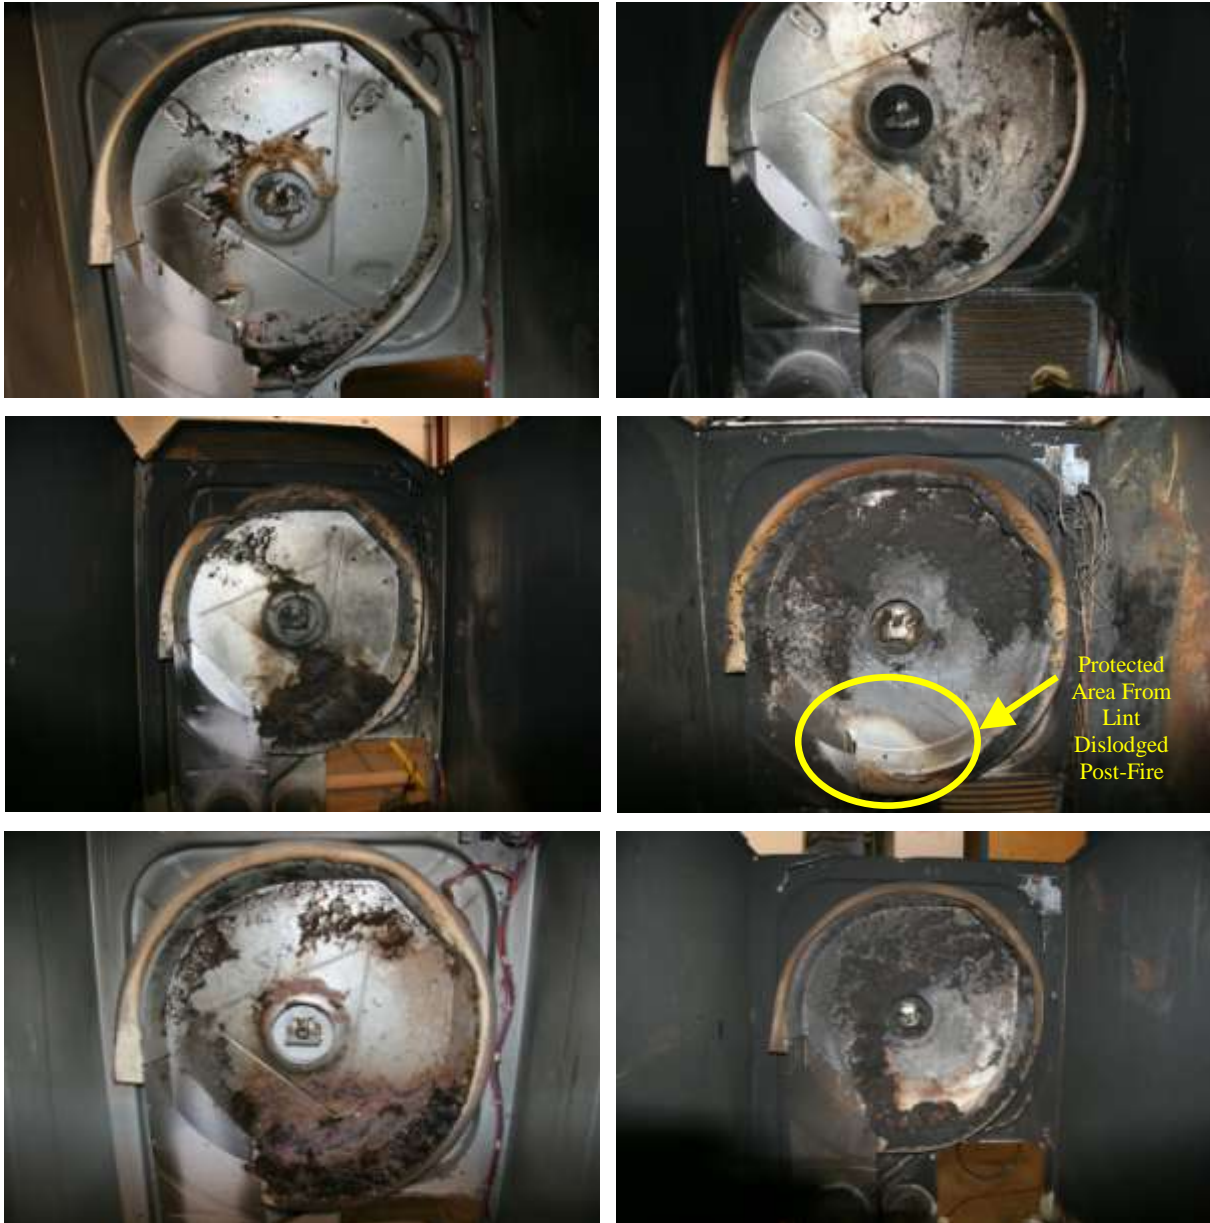
Photos of Lint Accumulations in Exemplar Burned Gas Dryers

detach from the rear of the drum and fall onto the heating element. In addition, this quantity of lint is an excellent source of secondary spread fuels that is in very close proximity to the heating element located directly behind the drum. The gas-fired dryers are equipped with a felt seal that surrounds the diffuser and forms a seal between the diffuser and the rear of the drum. The purpose of the seal in the gas dryer is to force the air to be drawn through the burner tube so the gas flame can heat the air as it is drawn into the diffuser and then is directed into the drum. Due to this seal forming an enclosure between the diffuser and rear of the drum, there are no openings through which any lint can escape. For this reason it is common to see large quantities of lint accumulated in the lower portion of the heat diffuser, immediately adjacent to the vertical heat duct that carries the heated air from the gas burner in the base of the cabinet. Though there are differences in the mechanisms by which the lint collects in the area behind the drum between the gas and electric designs, both allow for collection of lint in close proximity to the heat source which provides a higher probability of a lint fire occurring than alternative designs used in the industry.

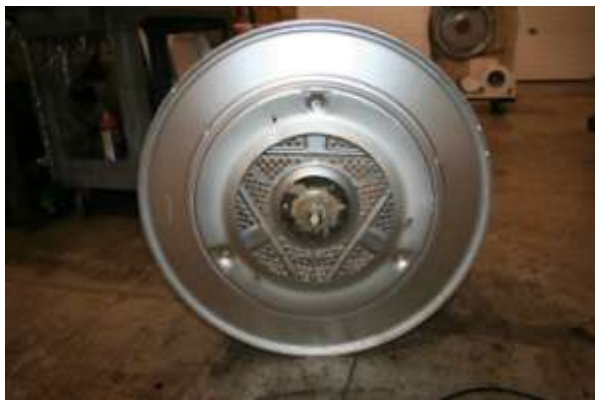
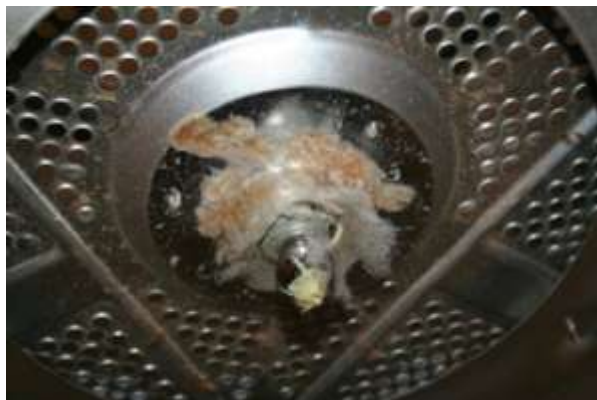
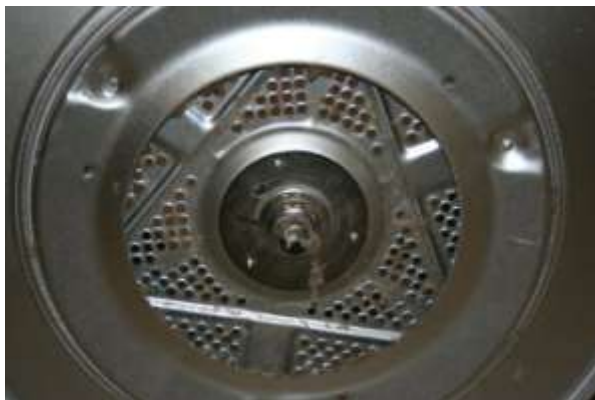
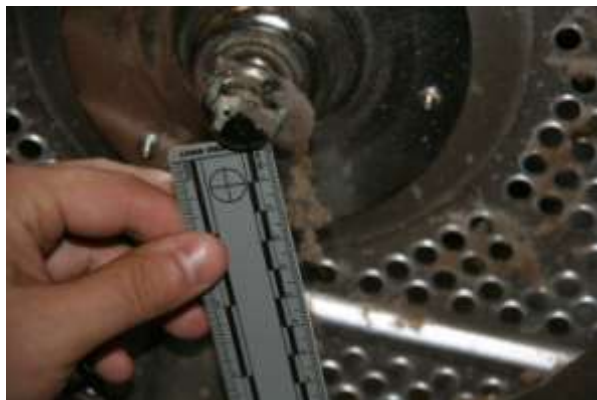
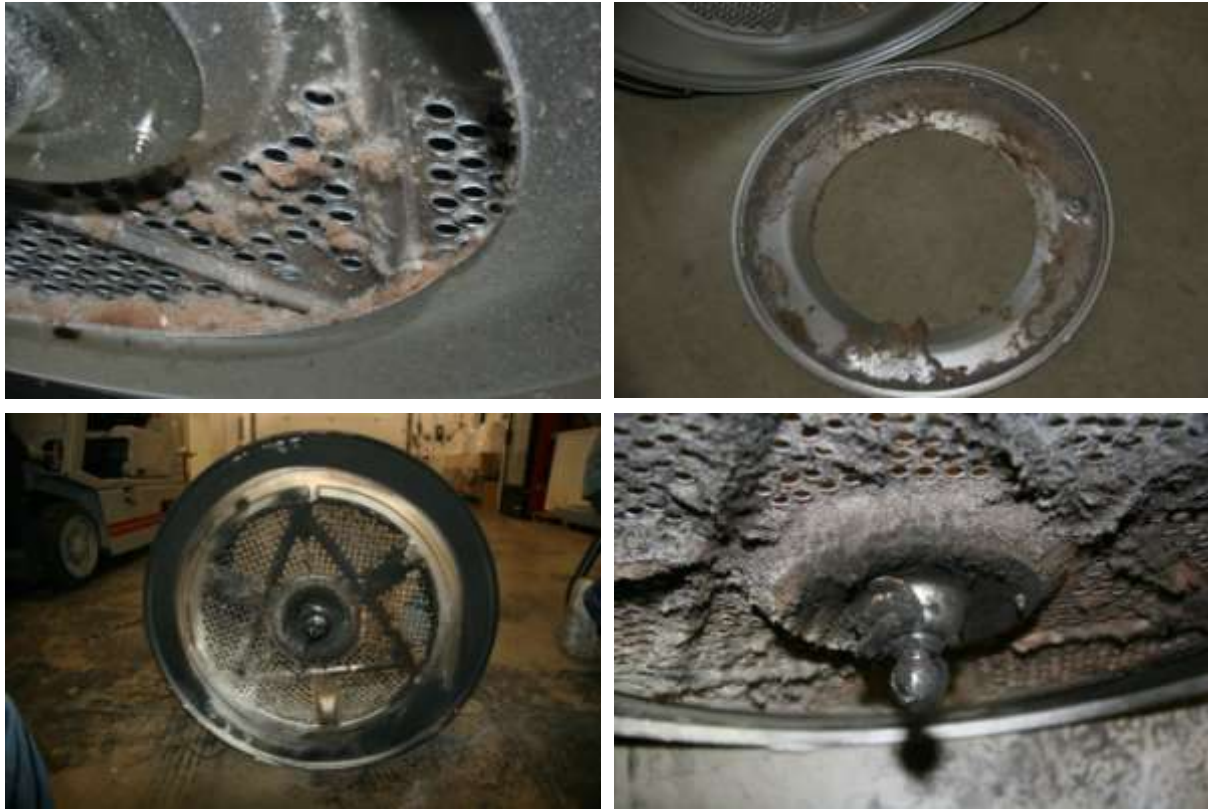
Photos of Lint Accumulations at the Rear of the Drum (Gas & Electric Models)

Lint also collects on the rear face of the drum. There are approximately 570 perforated holes on the rear wall of the drum that allow the air to be pulled from the heat diffuser to the rear into the laundry load within the drum. These holes are manufactured by punching through rear wall of the interior of the drum toward the rear. The result is smooth surfaces of each hole inside the drum, but a raised sharp surface on the rear wall of the drum, which further contributes to lint collection behind the drum. The shape and arrangement of these holes also allow lint to escape

In addition, all electrical models and some of the recent gas models have a heat shield or baffle installed on the rear of the drum. In electric dryers, this heat shield was used to protect the clothes from obtaining direct exposure to the heating element. This is not necessary in the gas models so we believe it may have been installed in recent models to change the airflow characteristics at the rear of the drum. With this heat shield or baffle installed on the rear of the drum, an additional void space is created that allows for the additional collection of lint between the baffle and the rear face of the drum. In some ignition scenarios, particularly involving the electric dryers, this accumulated lint is the first fuel ignited. In cases where there is a significant quantity of lint accumulated on the rear of the drum, this lint also acts as a secondary fuel load that can assist in either spreading fire to the clothing inside the drum or lint accumulated further downstream in the trap duct.

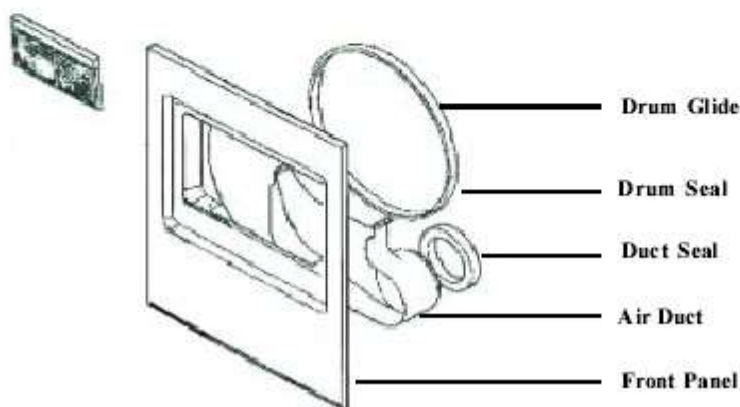
Electrolux Service Bulletin – November 2000, Page 16

In either model, this "short-cycling" can also be caused by a defective seal on the door, an improper seal at the drum glide or drum seal, or the air duct seal between the fan cover located on the fan housing and the duct that is mounted on the front panel (see illustration), as well as a defective blower fan. The result is that the load will take longer to dry.

The statement highlighted above expresses that Electrolux is aware that "short cycling" means that the dryer is operating off of its high temperature limiting safety device as opposed to its operational thermostat. This "short cycling" is manifested by extended drying times. The service bulletin goes on to describe four potential defects of the dryer components that should be assessed by the technician when diagnosing the cause of the extended drying times, including leaks at the door seal, drum glide or seal, seal between the trap duct and blower housing or a defective blower assembly. These defects are directly related to internal components and are independent of installation or maintenance issues that Electrolux typically blames as the only potential causes for reduced airflow within the dryer. And in the statement below, Electrolux warns servicers that vent restrictions are not the sole cause for large amounts of lint observed in the cabinet.

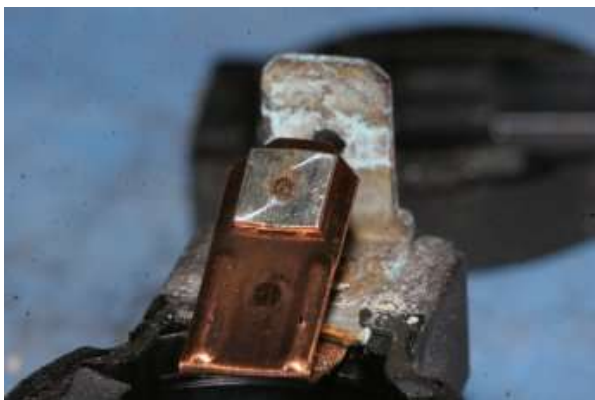
Un-Cycled Contact

Physical evidence of this condition can be found by a visual examination of the contact surfaces of the high limit safety device. The previously described parting arc creates temperatures of thousands of degrees or more. When this occurs, the surface of the contact is melted. As repetition of the parting arc occurs, the surface is melted again and again. Byproducts of the arc include vaporization of the metal contact material, which is observed in the form of a blackened or discolored area at the center of the contact, followed by pitting and eventually deformation of the contact surfaces as repeated cycling occurs. By examining the contacts, one can determine if the dryer had a reduced airflow condition that caused the high limit safety device to activate, and also can gauge the number of times this safety device cycled.

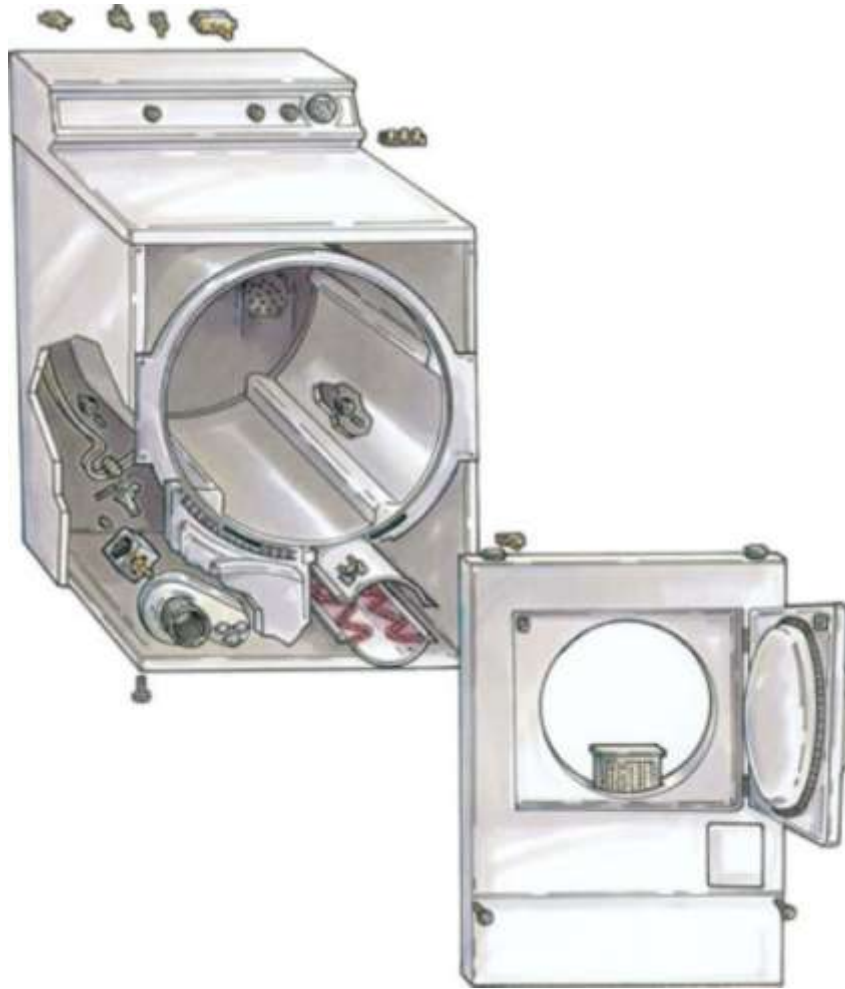
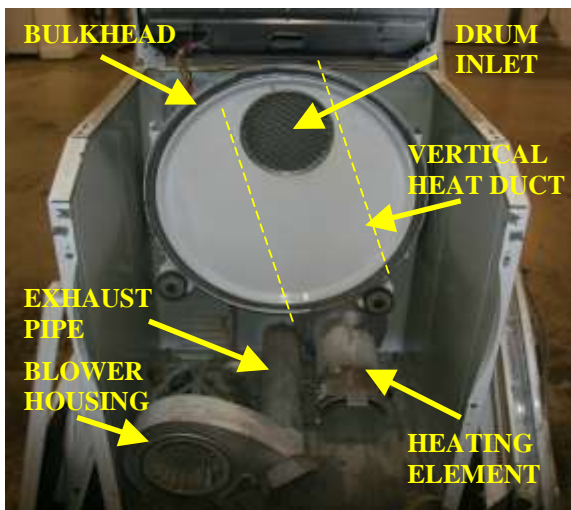
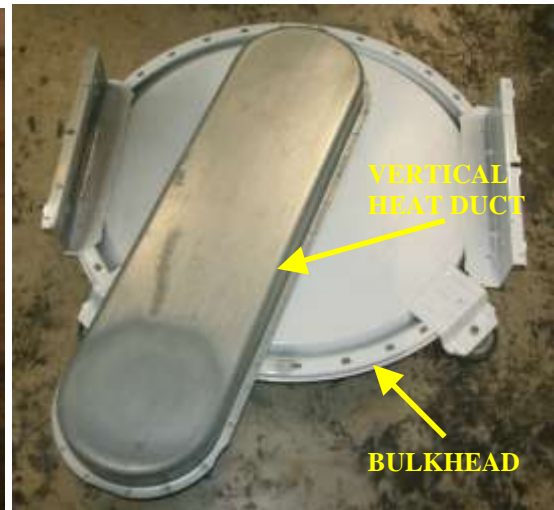
Maytag - Electric Dryer Design

In the Maytag design, the main location where lint accumulates is on the exhaust side of the drum, within the trap duct that connects the lint screen/lint trap to the blower housing. There are

no ignition sources located within the trap duct. Like the Whirlpool design, the Maytag dryers do allow for minor leakage at the front and rear drum seals for lint to collect in the base of the cabinet.

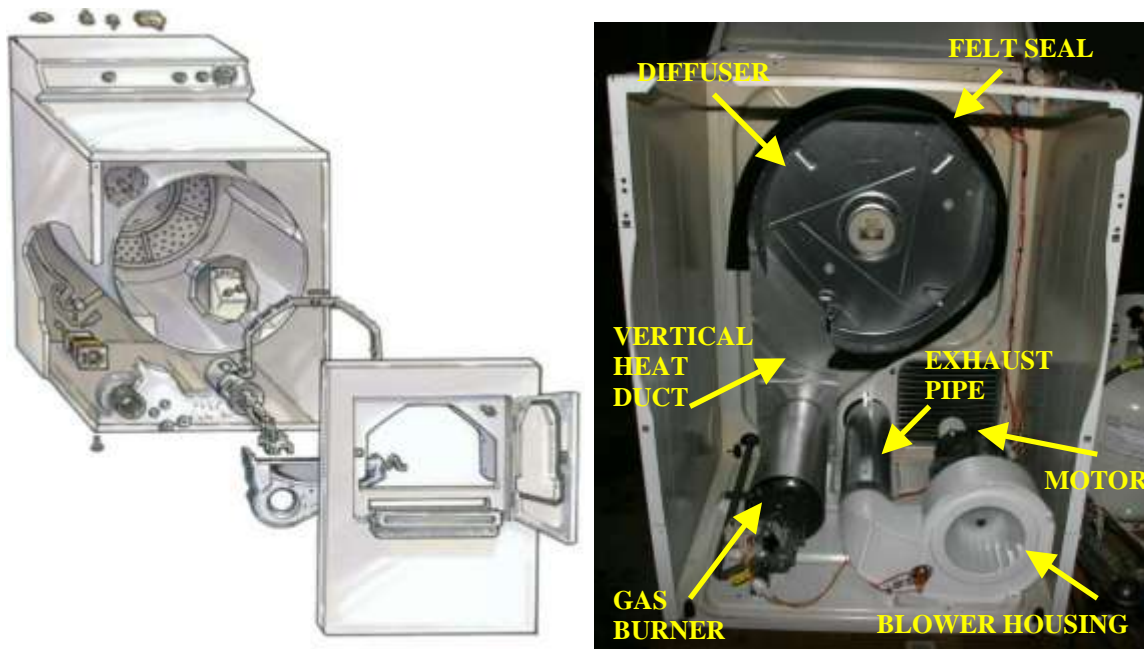
Electrolux/General Electric - Gas Dryer Design

The Electrolux gas models have a gas burner assembly located in the lower left portion of the cabinet. Heated air is drawn through the burner tube and up into the shallow, circular heat diffuser behind the drum through the vertical heat duct that connects these components. The heat diffuser is approximately the same diameter as the drum and is equipped with a felt seal that creates a sealed void space between the diffuser and the rear wall of the drum. The heated air is then drawn forward into the single-piece drum, through the laundry load rotating inside of the drum, and into the lint filter assembly that houses the lint screen at the lower front portion of the front drum opening. The air is then drawn into the constricted area of the trap duct that connects the lint filter assembly to the blower housing. Here the airflow transitions from vacuum to positive pressure and the warm air is pushed out of the dryer through the short section of metal exhaust pipe.

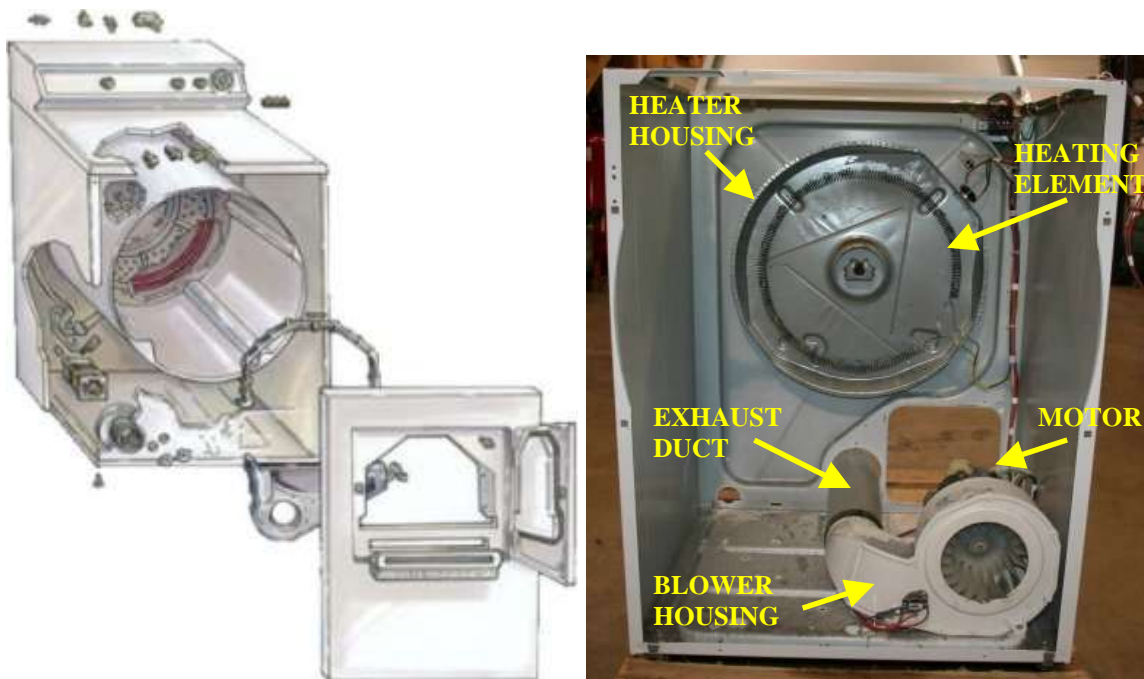
Electrolux/General Electric - Electric Dryer Design

The Electrolux electric models have a resistive coil-heating element located in the circular heater housing attached to the rear wall of the cabinet. The heater housing is approximately the same diameter as the drum. Ambient temperature air is drawn radially through the gap between the edges of the heater housing and the rear of the drum. There is no felt seal such as the one on the

gas Electrolux dryers that seals the gap between the drum and heater housing, as it necessary to pull air into the heater pan equally around its circumference. Just as in the gas model, the heated air is then drawn forward into the single-piece drum, through the clothing load rotating in this drum and into the lint filter assembly housing the lint screen at the lower front portion of the front drum opening. The air is then drawn into the constricted area of the trap duct that connects the lint filter assembly to the blower housing. Here the airflow transitions from vacuum to positive pressure and the warm air is pushed out of the dryer through the short section of metal exhaust pipe.

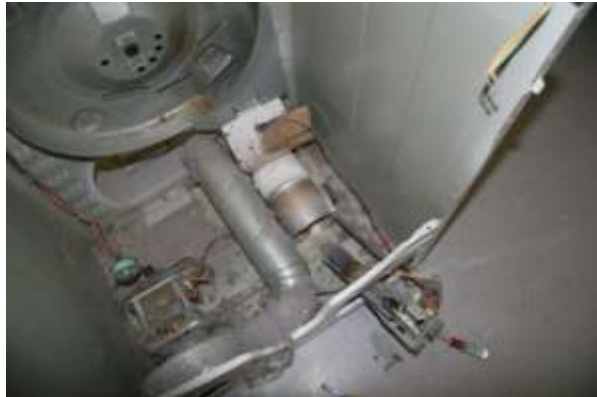
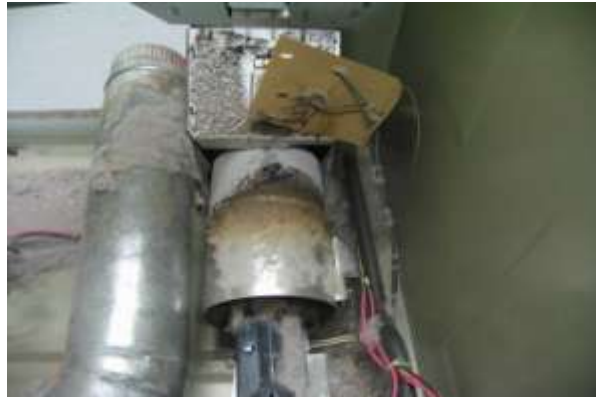
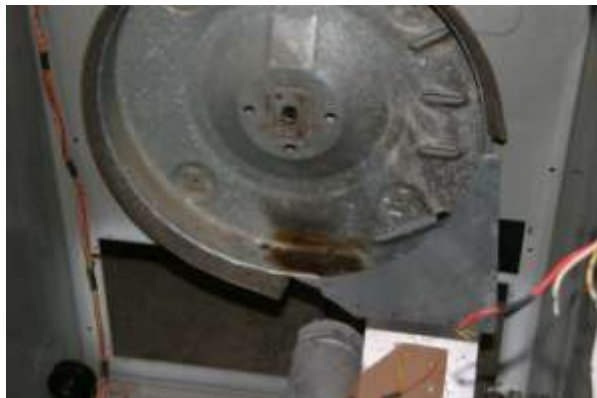
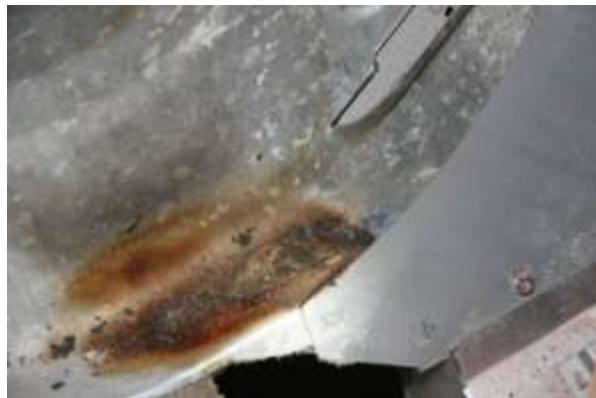
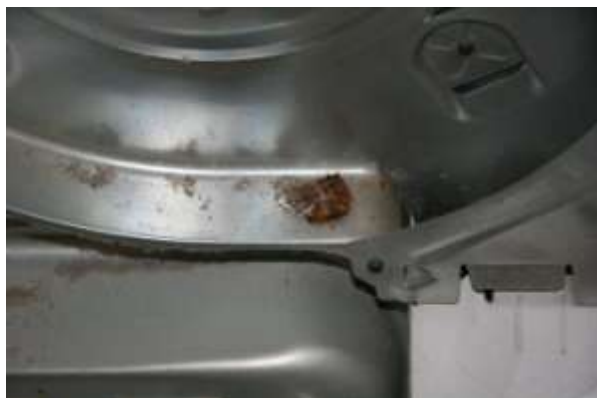
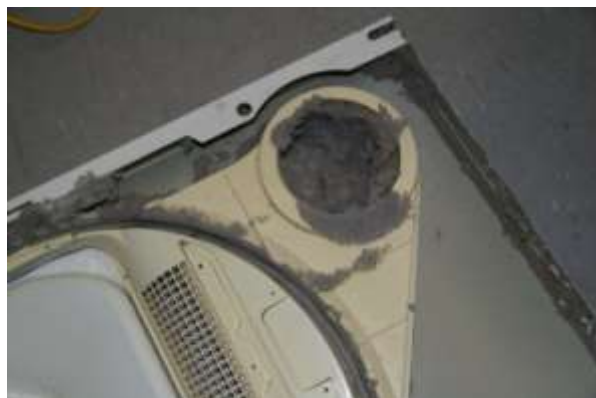
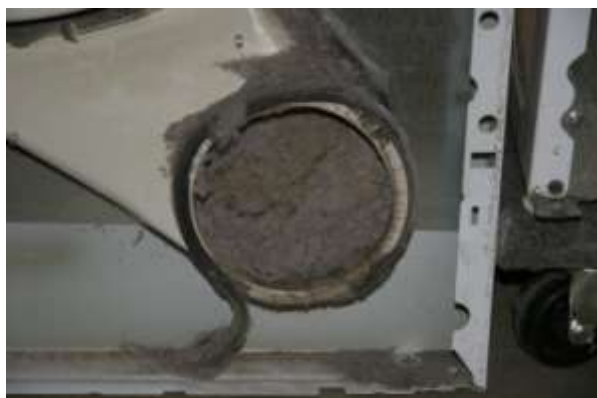
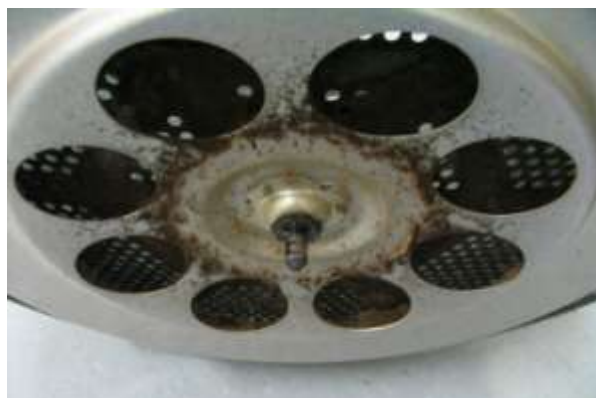
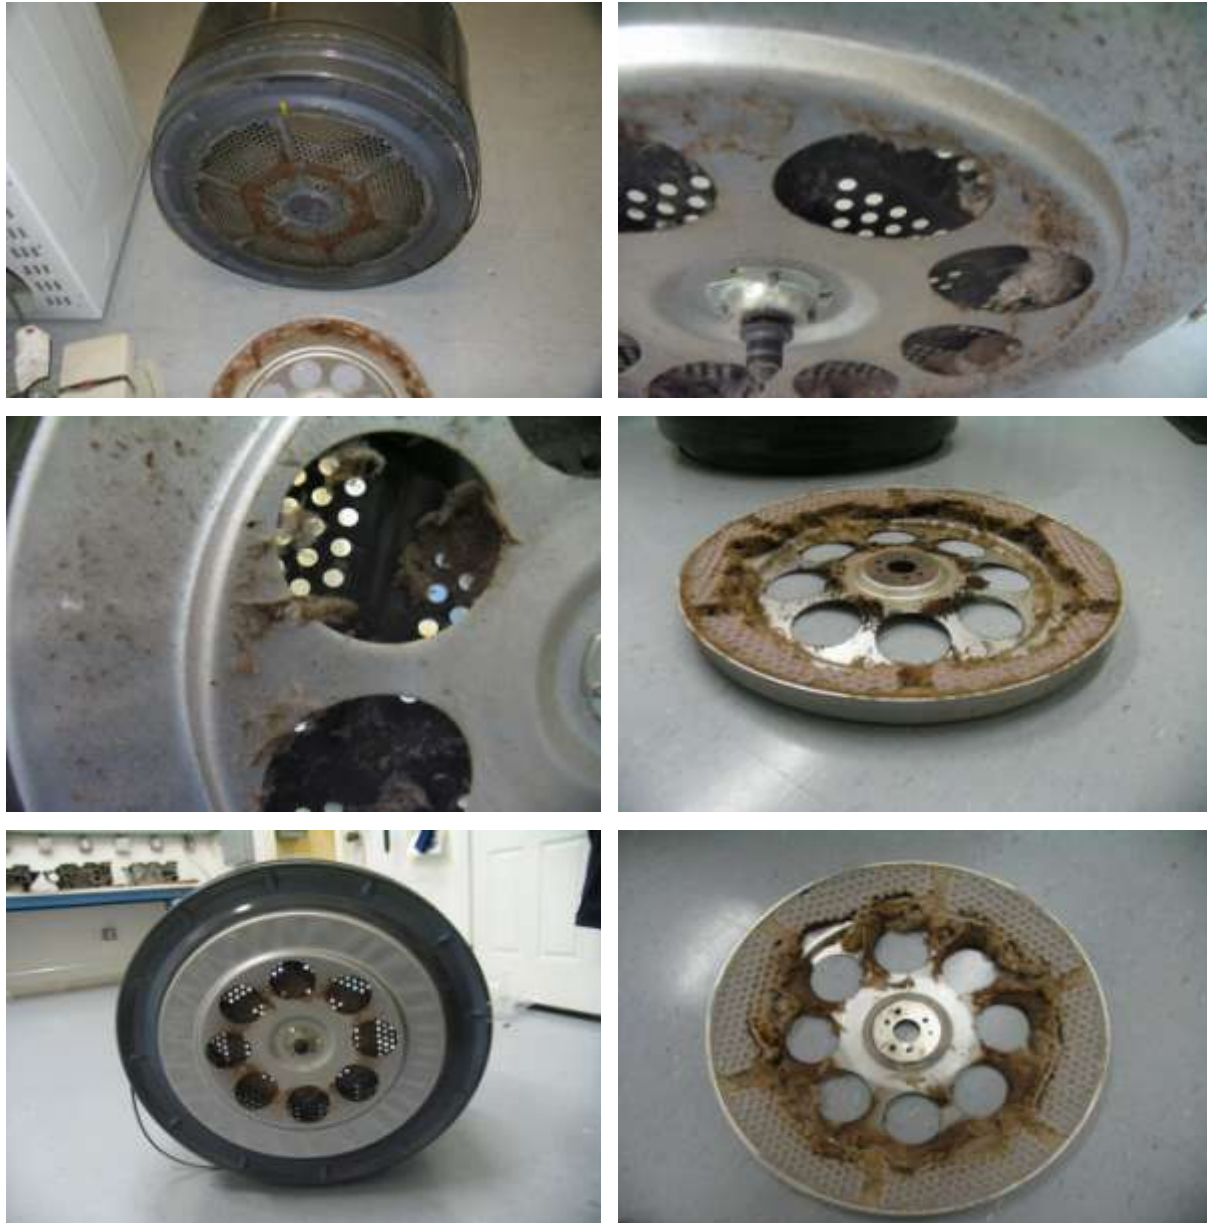
Photos of GE Exemplars with Lint

Also included for comparison are photographs of the Ball-Hitch design employed by GE, CAMCO and MABE, which share many features with the subject Electrolux dryer design. It should be noted in this substantially similar design, quantities of lint are regularly observed in the same area to the rear of the drum and in proximity to the heat source. These areas include the rear of the drum, the interior of the heat shield/baffle that attaches to the rear of the drum and in proximity to the vertical heat duct in the gas dryers and in proximity to the heating element in the heater pan of the electric dryers.

Comparison of the various designs of dryers revealed that the Electrolux/GE Ball-Hitch design types of dryers accumulated substantially more lint in critical areas where it is more probable that a fire will originate than in the alternative designs used by Whirlpool and Maytag Bulkhead designs. This lint accumulation was particularly noticeable in areas at or near the heat sources, such as behind the drum of the Electrolux/GE dryers.

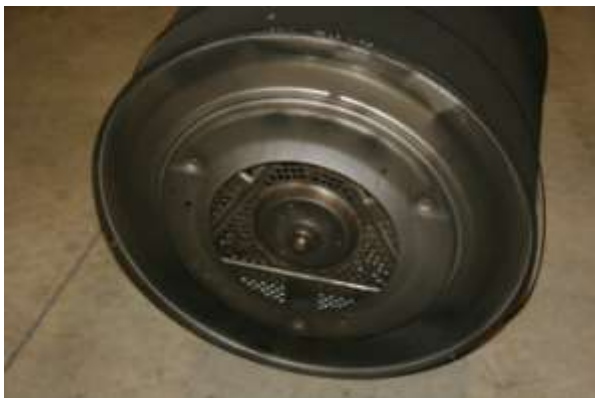
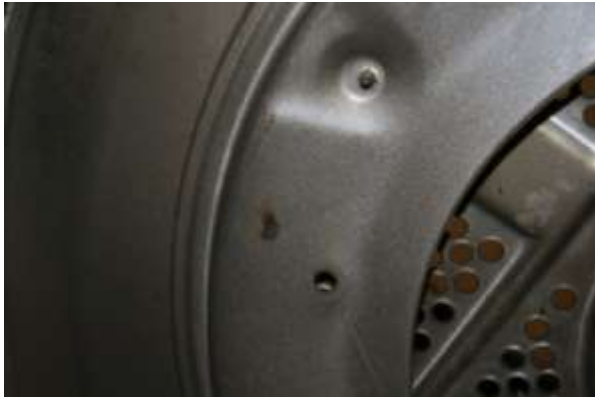
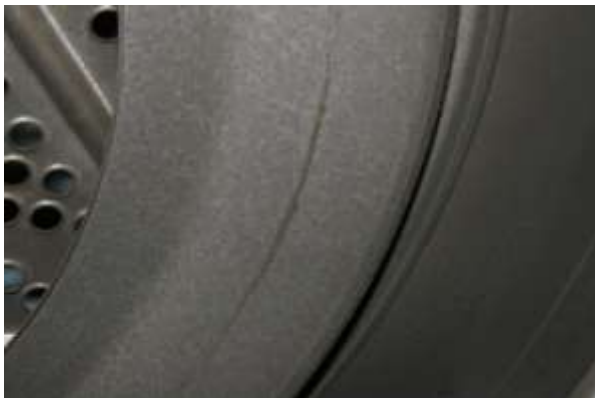
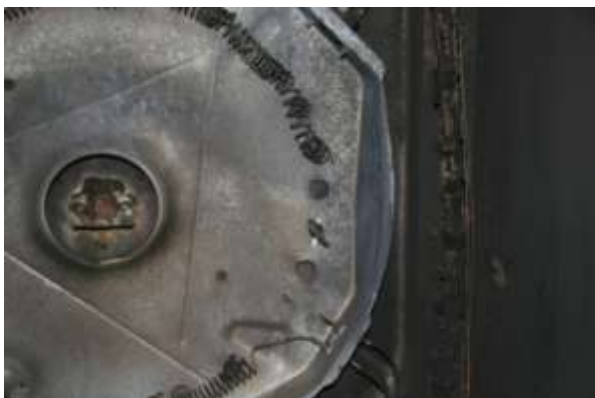
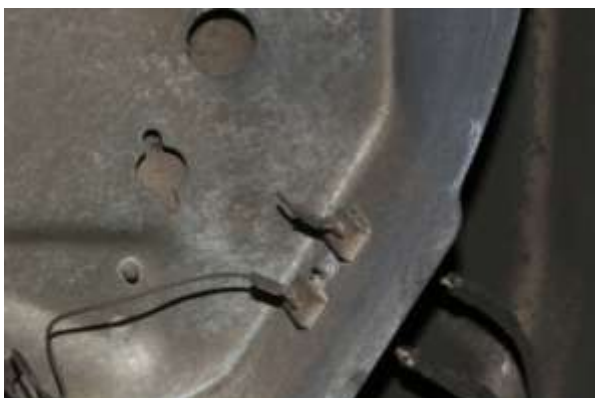
Example of Damage Related to a Bearing Failure

The first is a bearing failure that results in fire when the single rear bearing assembly that suspends the drum from the center of the heater housing fails, causing the rear of the metal drum and its clothing load to shift from its original position. When this occurs while the dryer is operating, the metal baffle/heat shield attached to the rear of drum contacts the energized heating element located approximately one inch from the rear of the drum, which results in a ground fault. This electrical short emits hot molten metal into the cabinet in the area at the rear of the drum. Any lint accumulated on the rear of the drum or within the cabinet can be ignited. The hot molten metal can also pass through the perforated ventilation openings in the rear of the drum and ignite the clothing load, particularly if the load is dry. The ability for the molten metal to be drawn into the rear of the drum is compounded by the negative pressure caused by the operating blower fan assembly, pulling air from the direction of the heating element behind the drum, into the clothing and toward the lint filter assembly at the front of the drum. It should be noted that other electric dryers of the other manufacturers' design types do not have their heating element located in this same location. Instead they are located in a metal duct in the cabinet below the drum. This eliminates the possibility of a bearing failure of any caliber to allow the drum to contact the heating element under any circumstances.

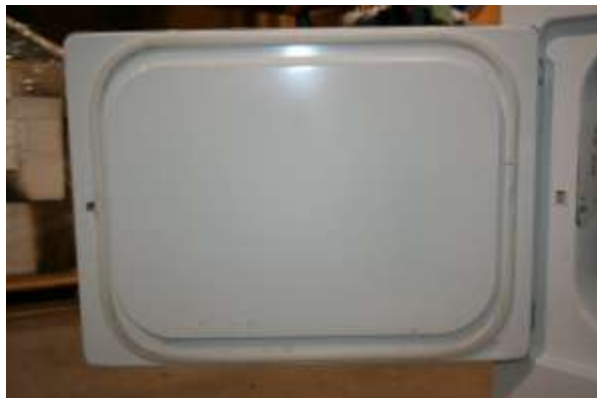
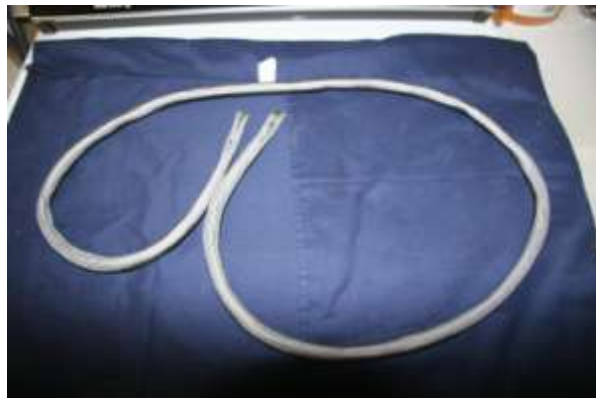
The exemplar dryers analyzed indicate that the door gasket used to seal the door in the front of the dryer opening fails when it is subject to fire. The gasket melts and burns away and allows fire to escape from the drum after the clothes load is ignited.

Replacing the plastic door gasket with a flameproof fibrous gasket

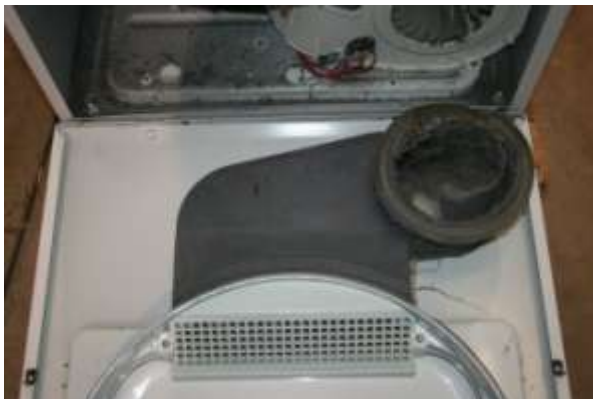
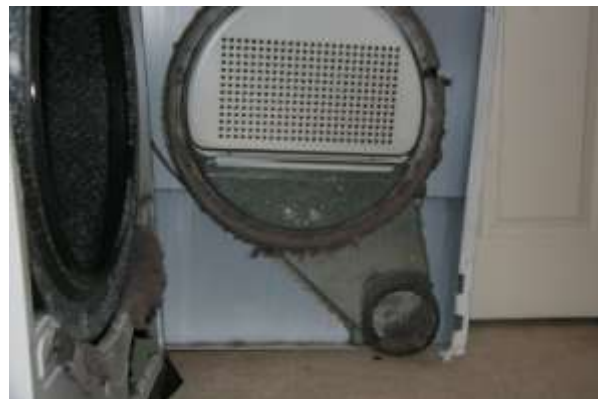
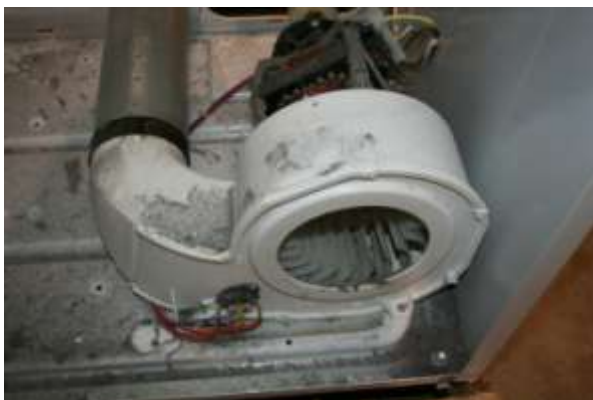
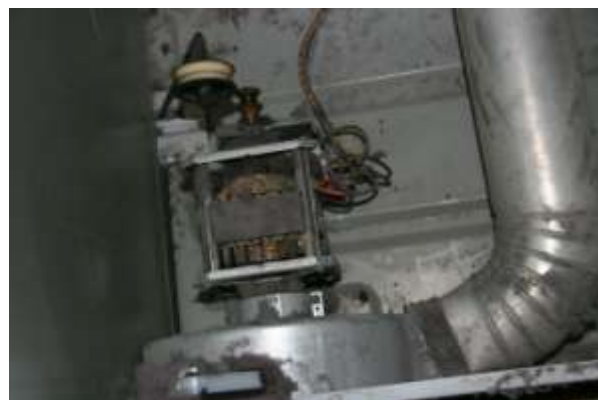
location. Fire also escaped the cabinet and spreads to nearby combustibles as the plastic trap duct and blower housing catch fire, causing the melted and burning plastic to flow from the cabinet to the exterior where this burning plastic can ignite other materials adjacent to the dryer.

Replacing the plastic trap duct and blower housing with steel components

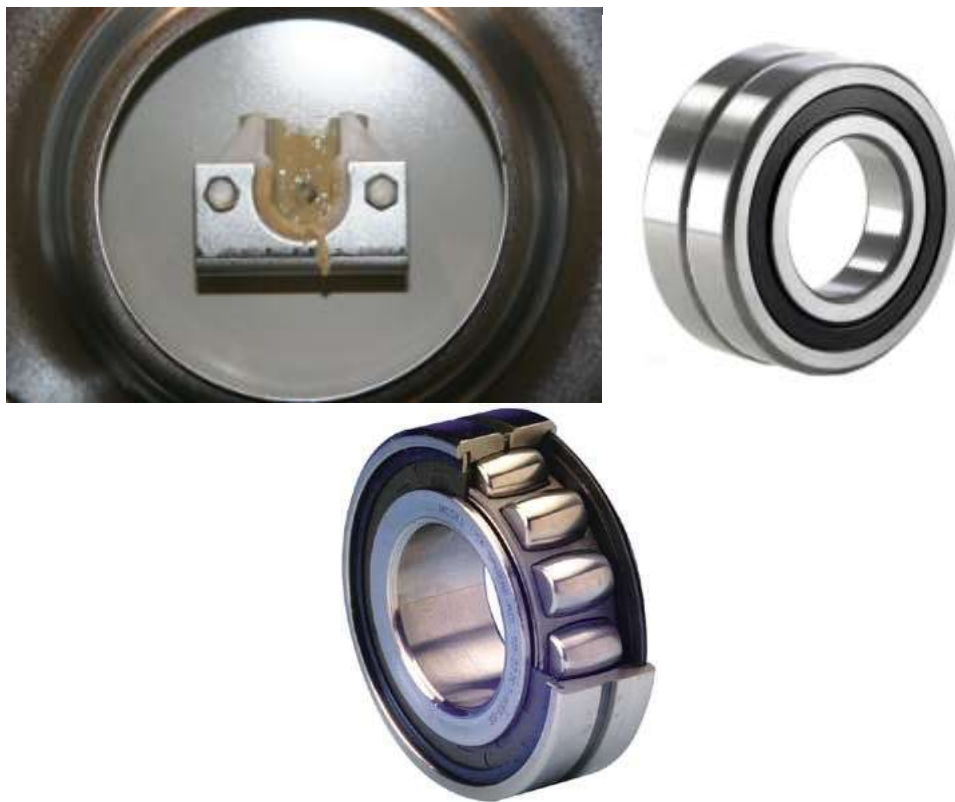
the rear of the cabinet at the center of the heater housing/diffuser assembly. If the plastic bearing material fails, the metal pivot rotates directly against the metal bracket of the ball/hitch resulting in scoring of the pivot shaft. Over a period of time, the scoring weakens the pivot until it is severed or breaks, allowing the drum to shift. The rear of the metal drum and/or attached heat shield is normally located less than one inch from the heating element, but under these circumstances the shifted drum can contact the heating element. If the heating element is energized, a ground fault occurs between the heating element and rear metal drum and/or baffle. The heating element typically breaks and a section of the heating element in the form of molten metal slag is released. Since the dryer is operating at the time, the airflow is being pulled into the rear of the drum, drawing this hot slag into any lint collected at the rear of the drum and/or into the clothing load, resulting in a potential fire. In addition, the shift in the drum will allow for lint that collects within the baffle/heat shield and on the rear of the drum to migrate closer to the heating element or even come into direct contact with the heating element and be ignited.

Replacement of the plastic bearing material with steel bearing materials

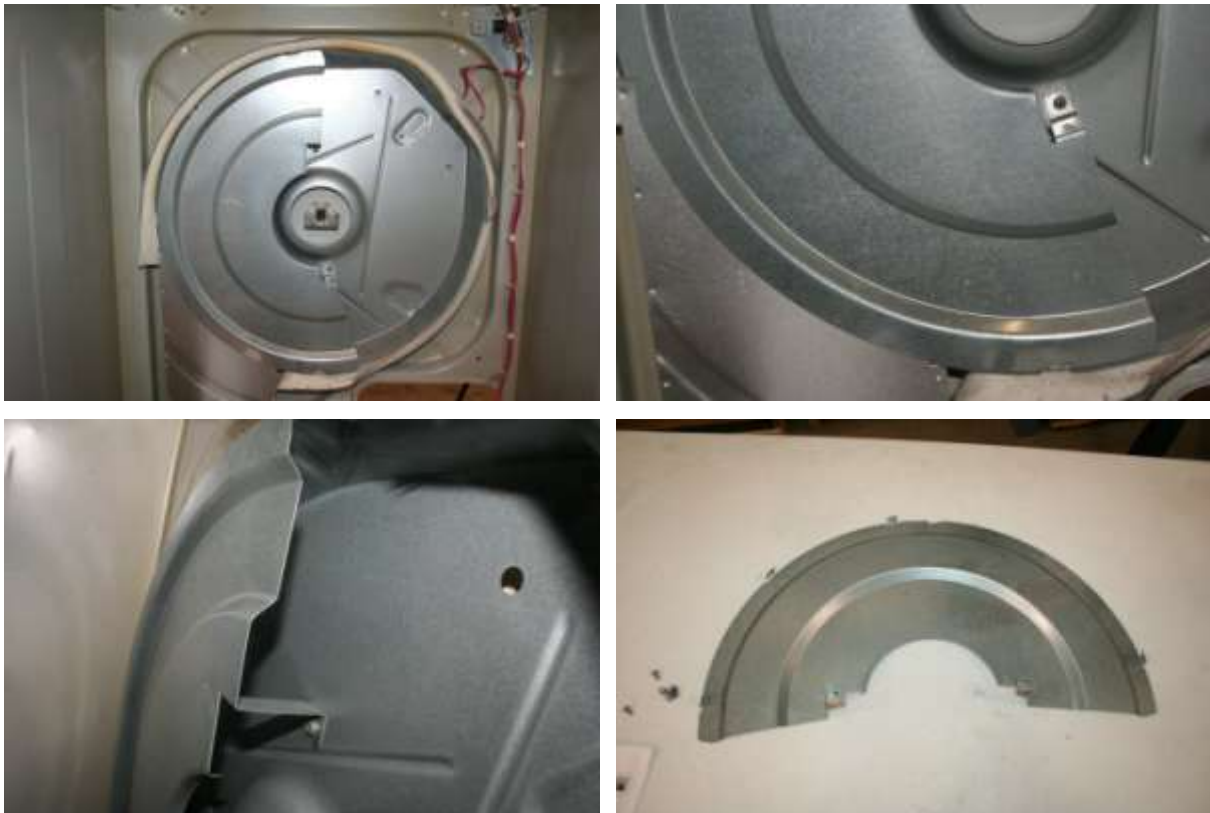
The gas dryers manufactured by Electrolux for General Electric contained a similar guard that was used as the primary basis of this design. This guard was only installed in gas GE models, not in Frigidaire models. The Wright Group improved the design by enclosing the lower half, below the drum pivot opening and adding a baffle to prevent the ignition of lint that collects in the lower half of the heat diffuser. The exemplar dryer below was a General Electric gas dryer manufactured by Electrolux in December 2003.

Electrolux Manufactured Guard in GE Gas Dryer Model DVL223GB5WW
